Inspection Report

Property Address:
1234 Anywhere Lane
Sometown, FL

Proteam Inspections, Inc.

Date: 2/1/2016	Time:	Report ID: TAM020116
Property: 1234 Anywhere Lane Sometown, FL	Customer: John Doe	Real Estate Professional: Real Person Keller Realty

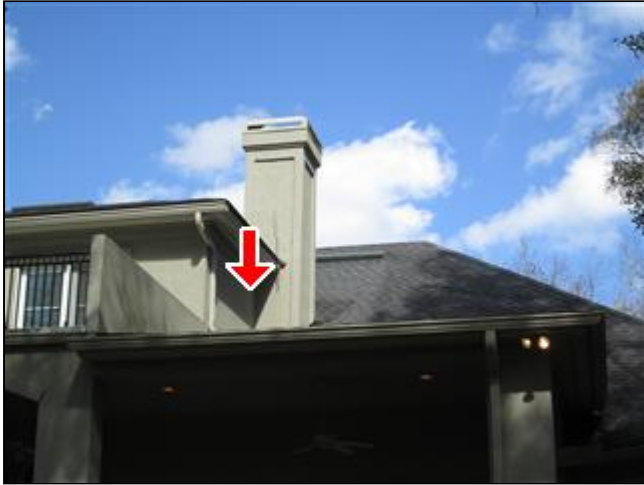
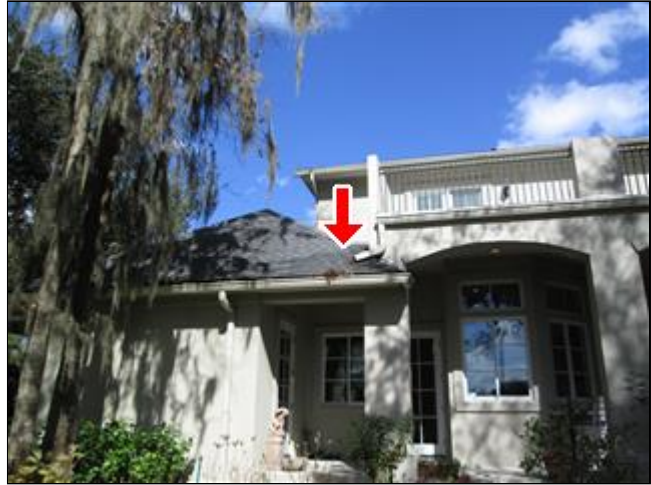
The roof covering has several areas with past roof repairs. the repairs are located at the rear elevation of the roof adjacent to the rear balcony area (pictures 1 and 2 and at the area adjacent to the fireplace chimney (pictures 3 and 4).

The repairs adjacent to the balcony area appear to be proper and should perform well. The repair adjacent to the fireplace chimney was not a proper repair and should be reviewed for repair to include repair of the plywood roof substrate in this area as well as proper replacement of the shingles.

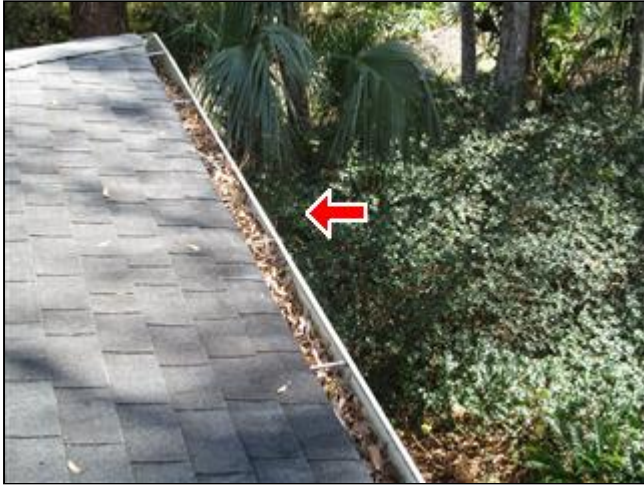
1.7 Picture 1

Gutter needs cleaning of debris at virtually all areas where gutters are installed.

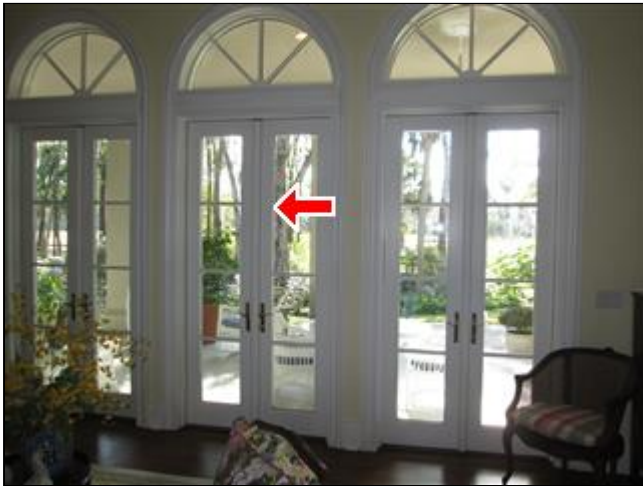
3.1 Picture 1

The center patio door in living room rubs other door when closed. Advise to adjust as needed.

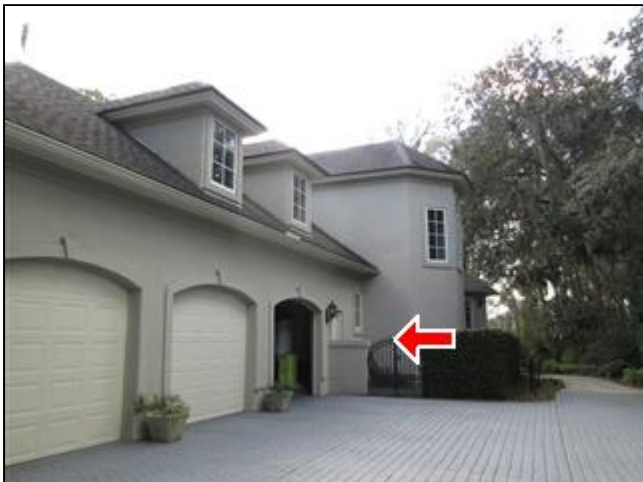
3.2 Picture 1

The garage service door has wood deterioration located at the lower exterior door jamb. Advise repairs as needed.

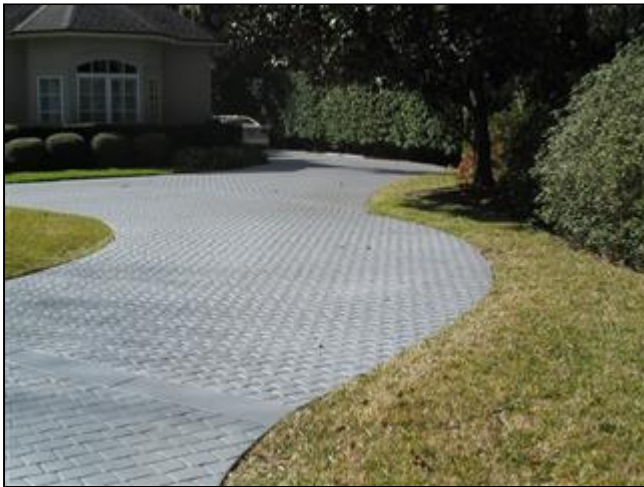
5.1 Picture 1

Typical minor settlement cracks only. The drive is stable.

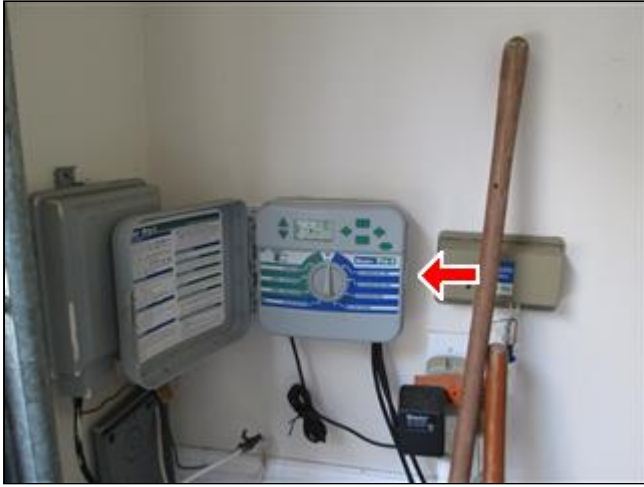
5.2 Picture 1

Irrigation system was functional at time of inspection.

Advise to maintain adjustments to sprinkler heads to prevent overspray to exterior cladding which can cause damage to exterior cladding and windows.

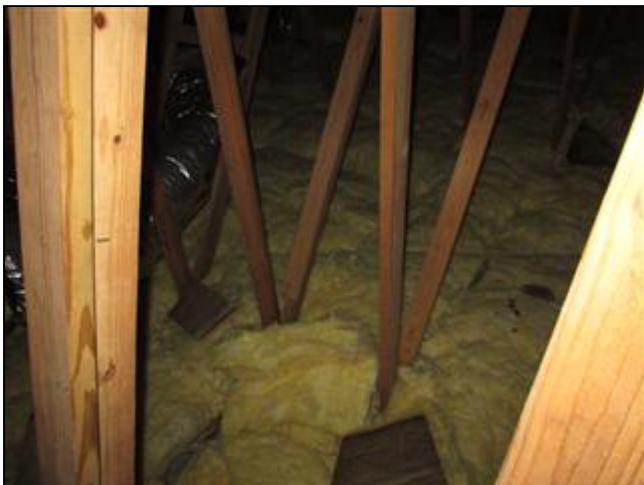
6.1 Picture 1

Fiberglass (Batts) insulation is about 9 1/2 inches thick or R-30-Value (Picture 1).

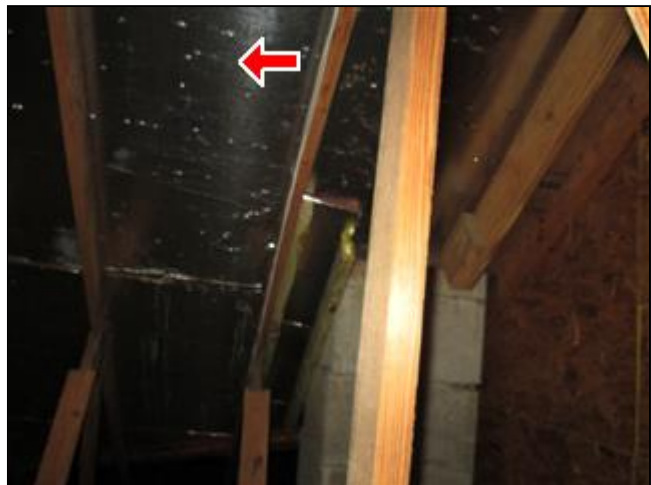
6.1 Picture 2

This home utilizes solar board technology: (Picture 2).

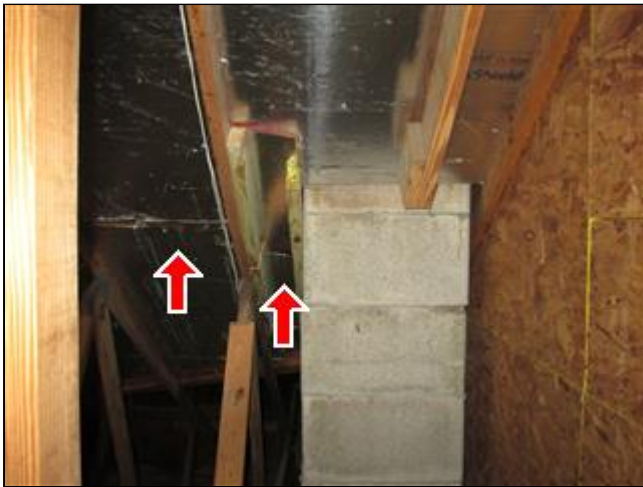
6.5 Picture 1

The area of roof decking and chimney chase at living room fireplace has moisture damage (Picture 1).

Advise review and repair as needed by a licensed qualified contractor of the following areas:

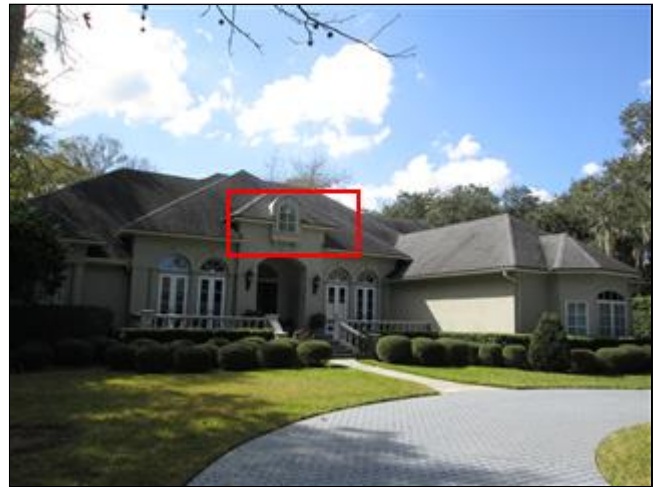
6.5 Picture 2

The OSB plywood stucco wall substrate above front entry has moisture damage. (picture 2)

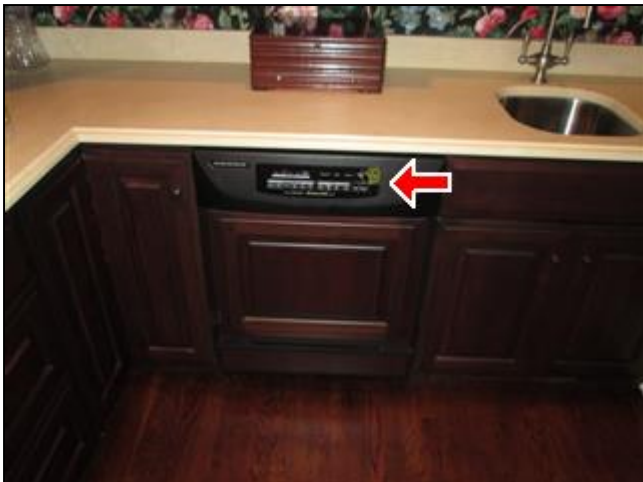
8.6 Picture 1

The dishwasher at butler pantry did not turn on (Picture 1). Advise review by a appliance technician.

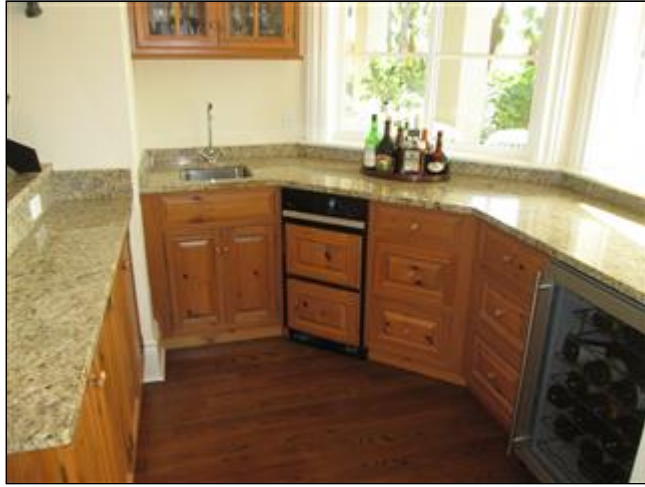
10.6.B Picture 1

The ice maker was not turned on at time of inspection. Advise review with sellers.

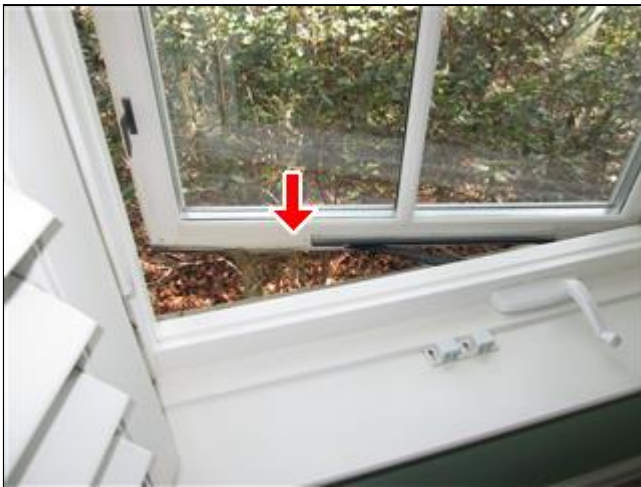
11.4 Picture 1

The lower seal at right side window in master bedroom is loose (Picture 1). Advise repair as needed.

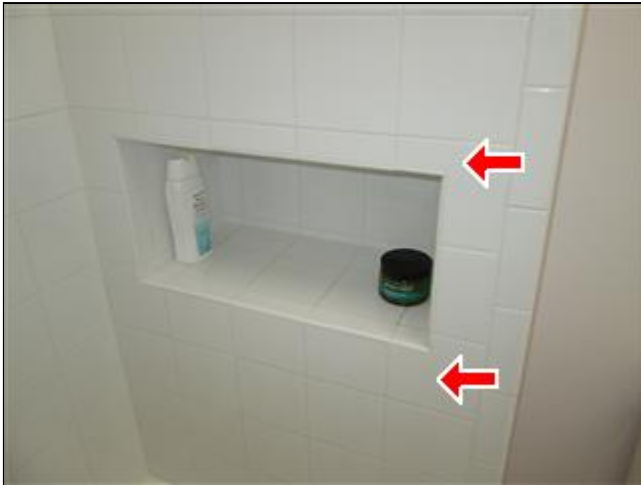
12.0 Picture 1

The tile surround at second floor left rear bedroom bath has two cracked tile on right side of recess area (Picture 1). Advise to review and to repair or maintain caulk/seal at cracks and open grout joints.

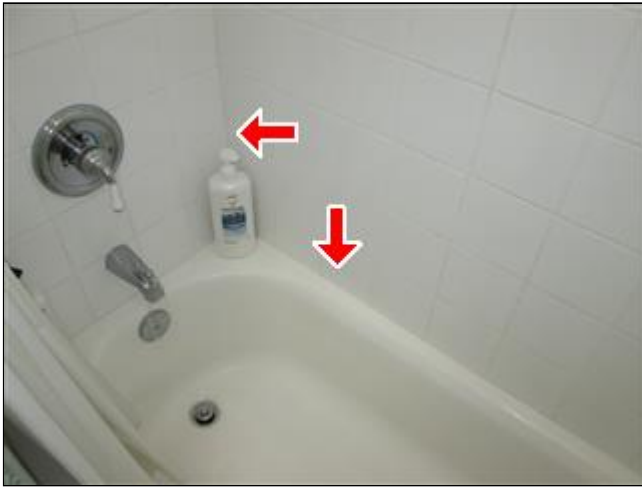
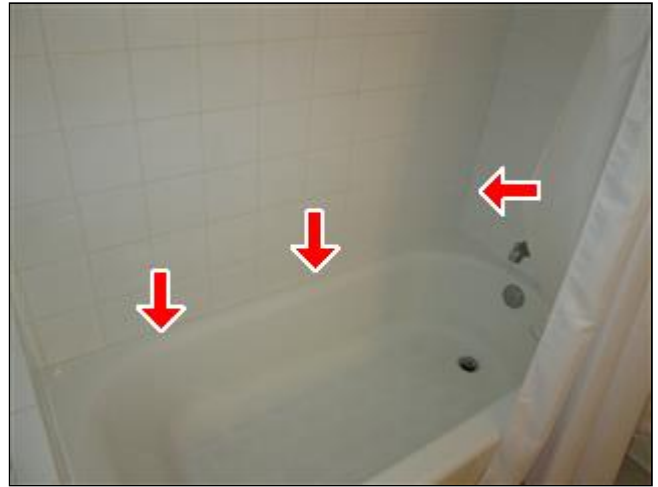
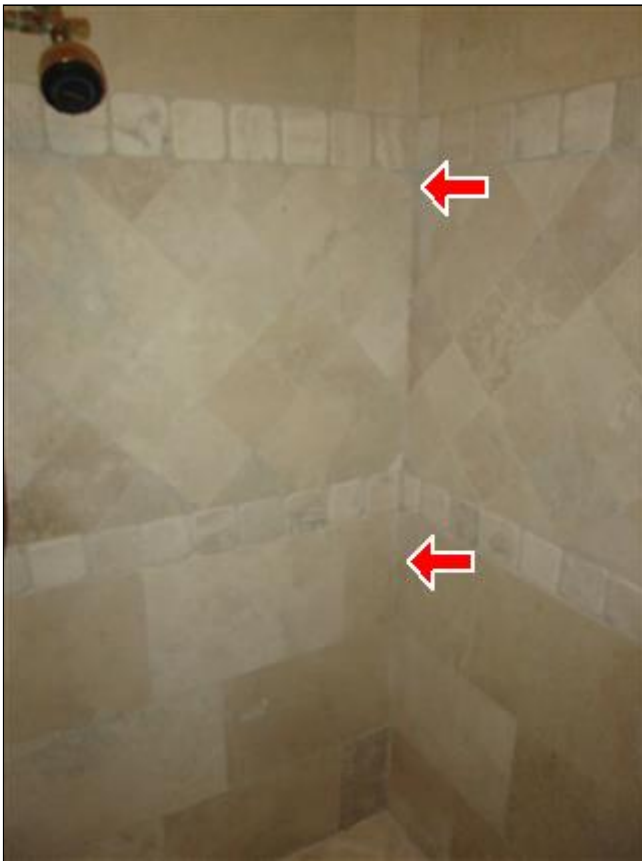
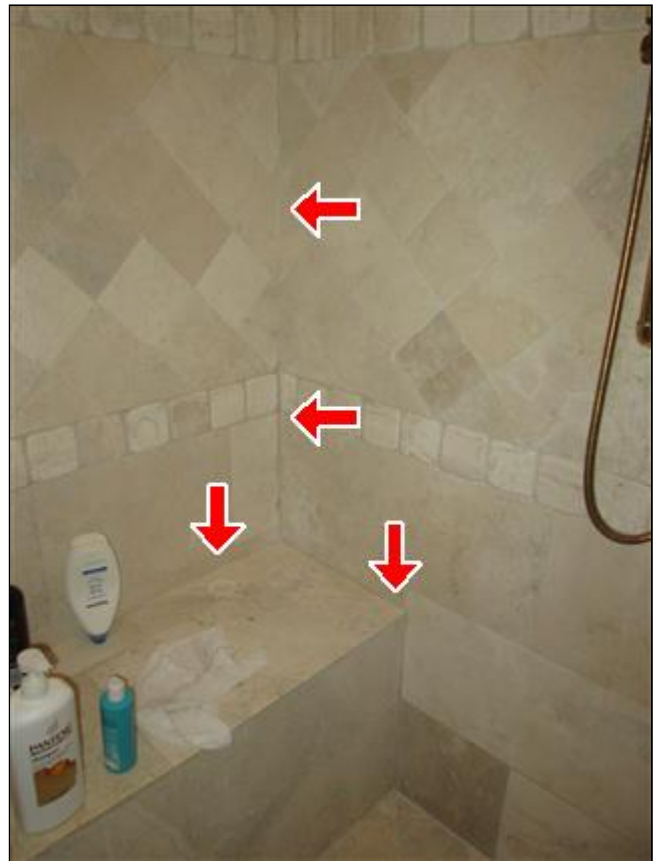
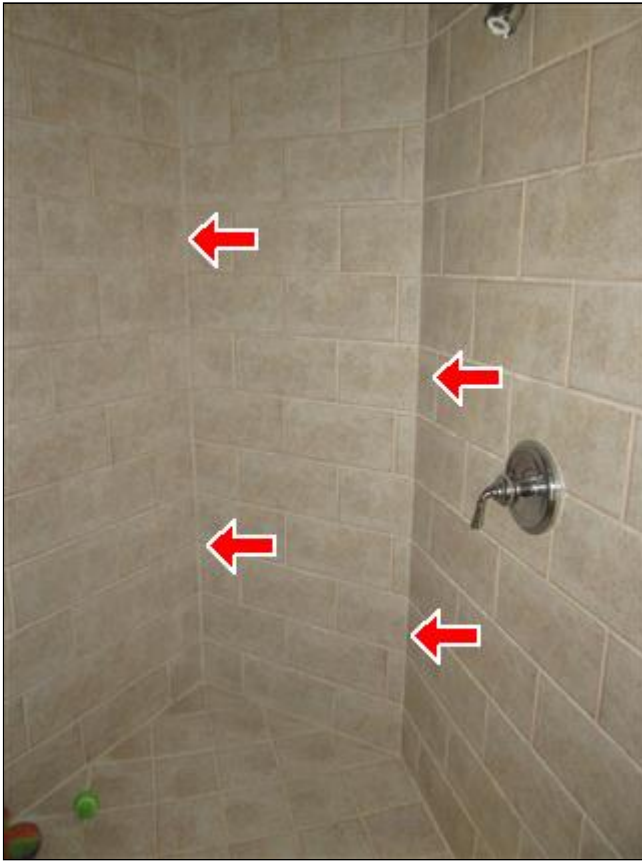
Recommend to review and silicone caulk as needed along perimeter of tubs and wall surround and along floor, door threshold and wall surrounds of showers (Pictures typical).

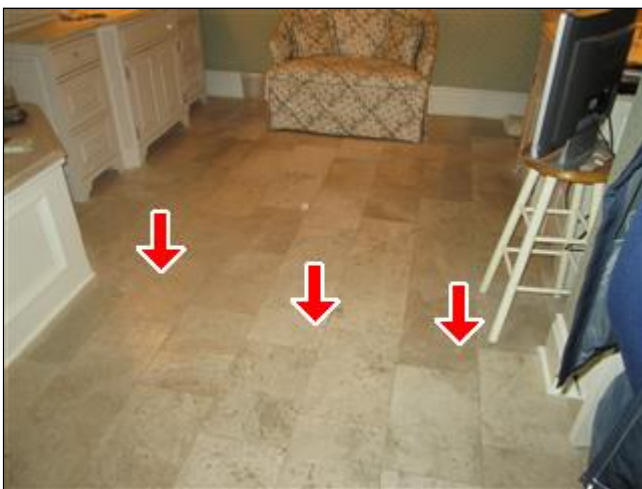
12.4 Picture 1

The master bath tile floor has several cracked tiles (Picture 1 typical). This is caused by settlement crack in concrete slab and is not a structural concern.

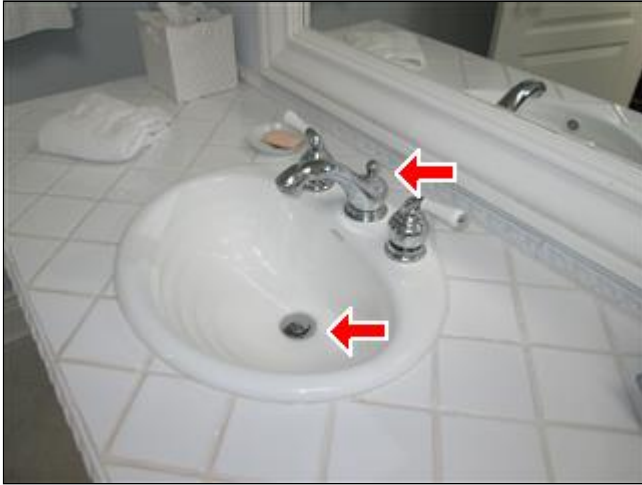
13.4 Picture 1

The drain stop at second floor rear right side guest bedroom bath will require adjustment to open and close properly (Picture 1).

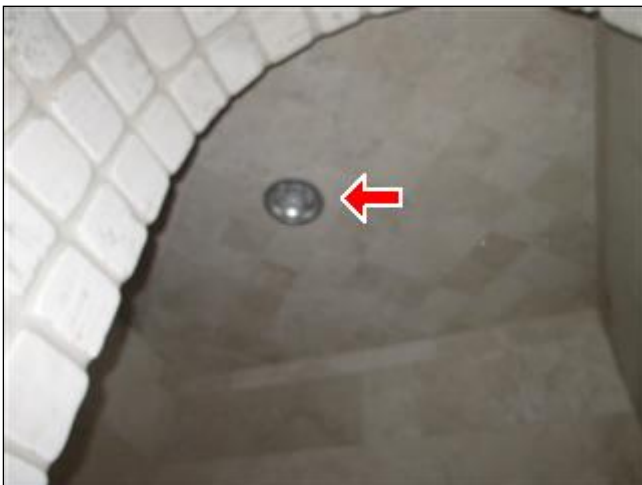
13.10 Picture 1

The recess light above master bath shower is missing globe cover (Picture 1).

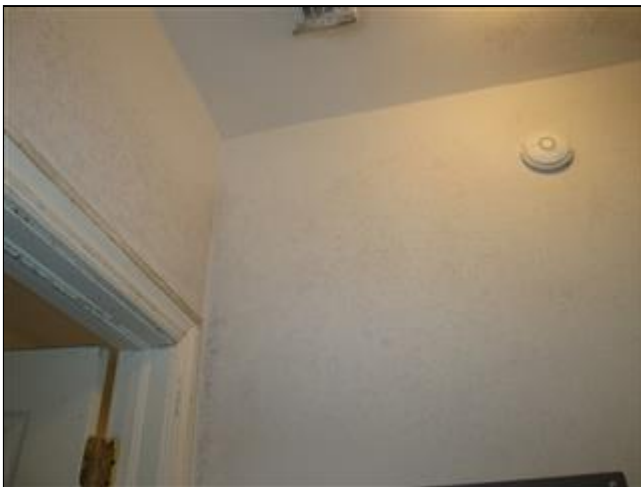
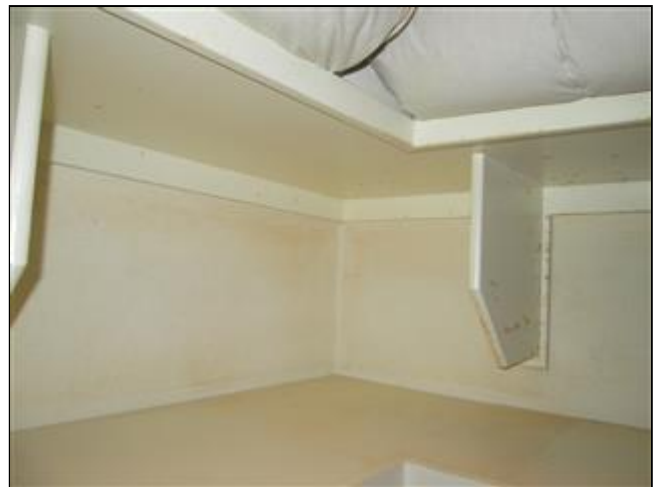
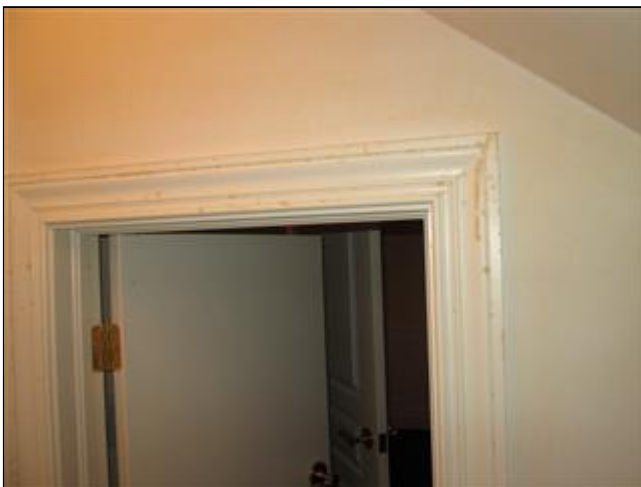
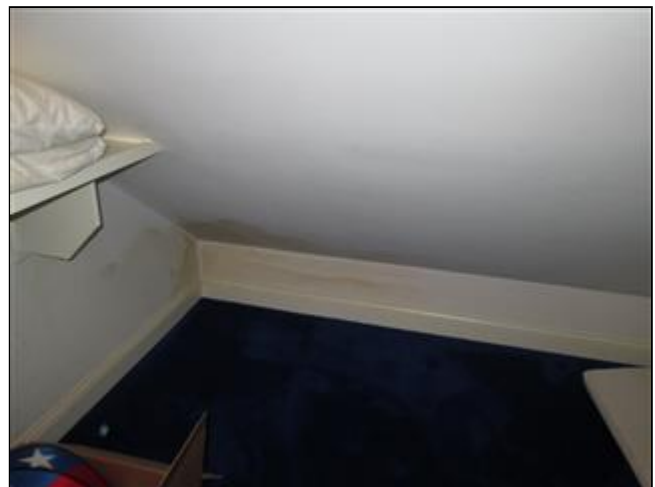
The closet at second floor mechanical area (air handler, water heater and sub-panel) and the closets in lower second floor bedroom have discoloration on walls (Pictures typical). This appears to be from minimal ventilation. Advise review by a HVAC contractor.

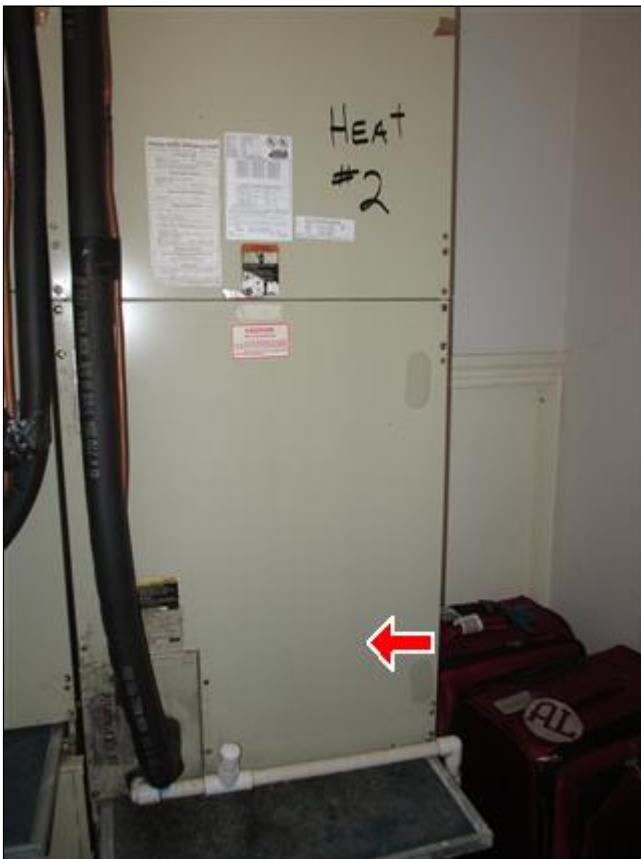
17.2 Picture 1

The coils are dirty at unit #2 (Picture 1). Advise to have cleaned by a licensed HVAC contractor.

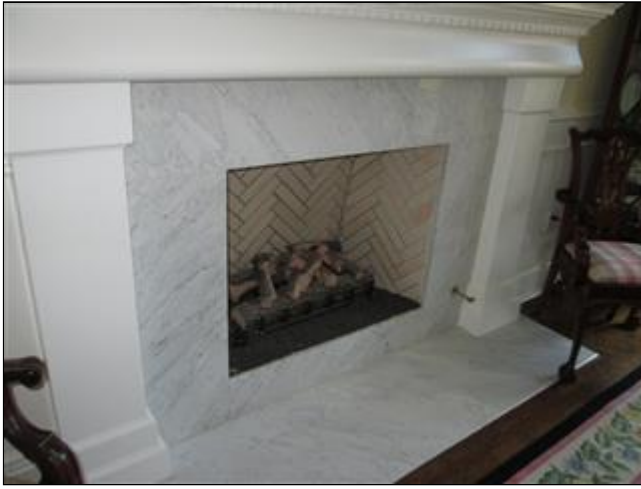
18.0 Picture 1

Gas fireplaces were not operated at time of inspection (Picture 1 typical). Advise to check with seller for operating instructions.
