Polybutylene for Inspectors

by Nick Gromicko and Kenton Shepard

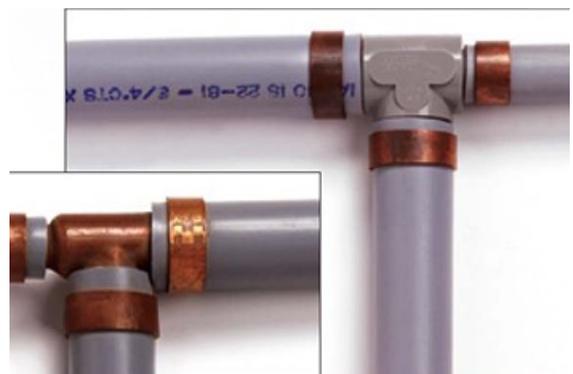
An inspector can use the following tips to identify polybutylene plumbing. Polybutylene pipes are:

- usually stamped with the code "PB2110";
- flexible and sometimes curved, unlike rigid piping materials such as copper;
- not used for waste, drain or vent piping;

- most commonly grey in color, but they can also be white, silver, black or blue. Blue PB is used primarily outdoors and should only be used to carry cold water. Inspectors should be aware that black or white pipes might not be polybutylene (they might be polyethylene or PVC, respectively). Also, PB color is somewhat region-dependant. For instance, experienced home inspectors in California might never come across grey PB, while it is quite common elsewhere;
- ½” to 1” in diameter.

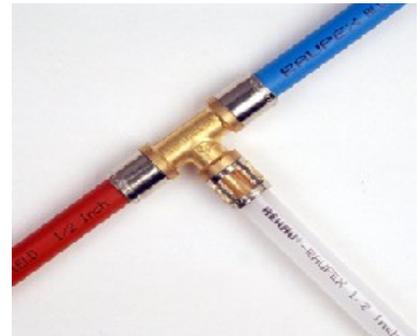
- PEX (pictured at right): Common in radiant-heating systems, this cross-linked polyethylene can be black, blue or red. It is more easily coiled and more flexible than PB. It can withstand higher temperatures than polyethylene.
- PVC: A popular building material commonly used in residential plumbing. CPVC is derived from PVC and is also used in plumbing. Both appear white or off-white and can be flexible or rigid.
- Polyethylene: This material is flexible and black.
- Copper: Copper is a metal that should never be confused with PB.
